# Environmental Projects: Volume 4

## Asbestos Survey

Goldstone Deep Space Communications Complex

Jet Propulsion Laboratory  
California Institute of Technology  
Pasadena, California

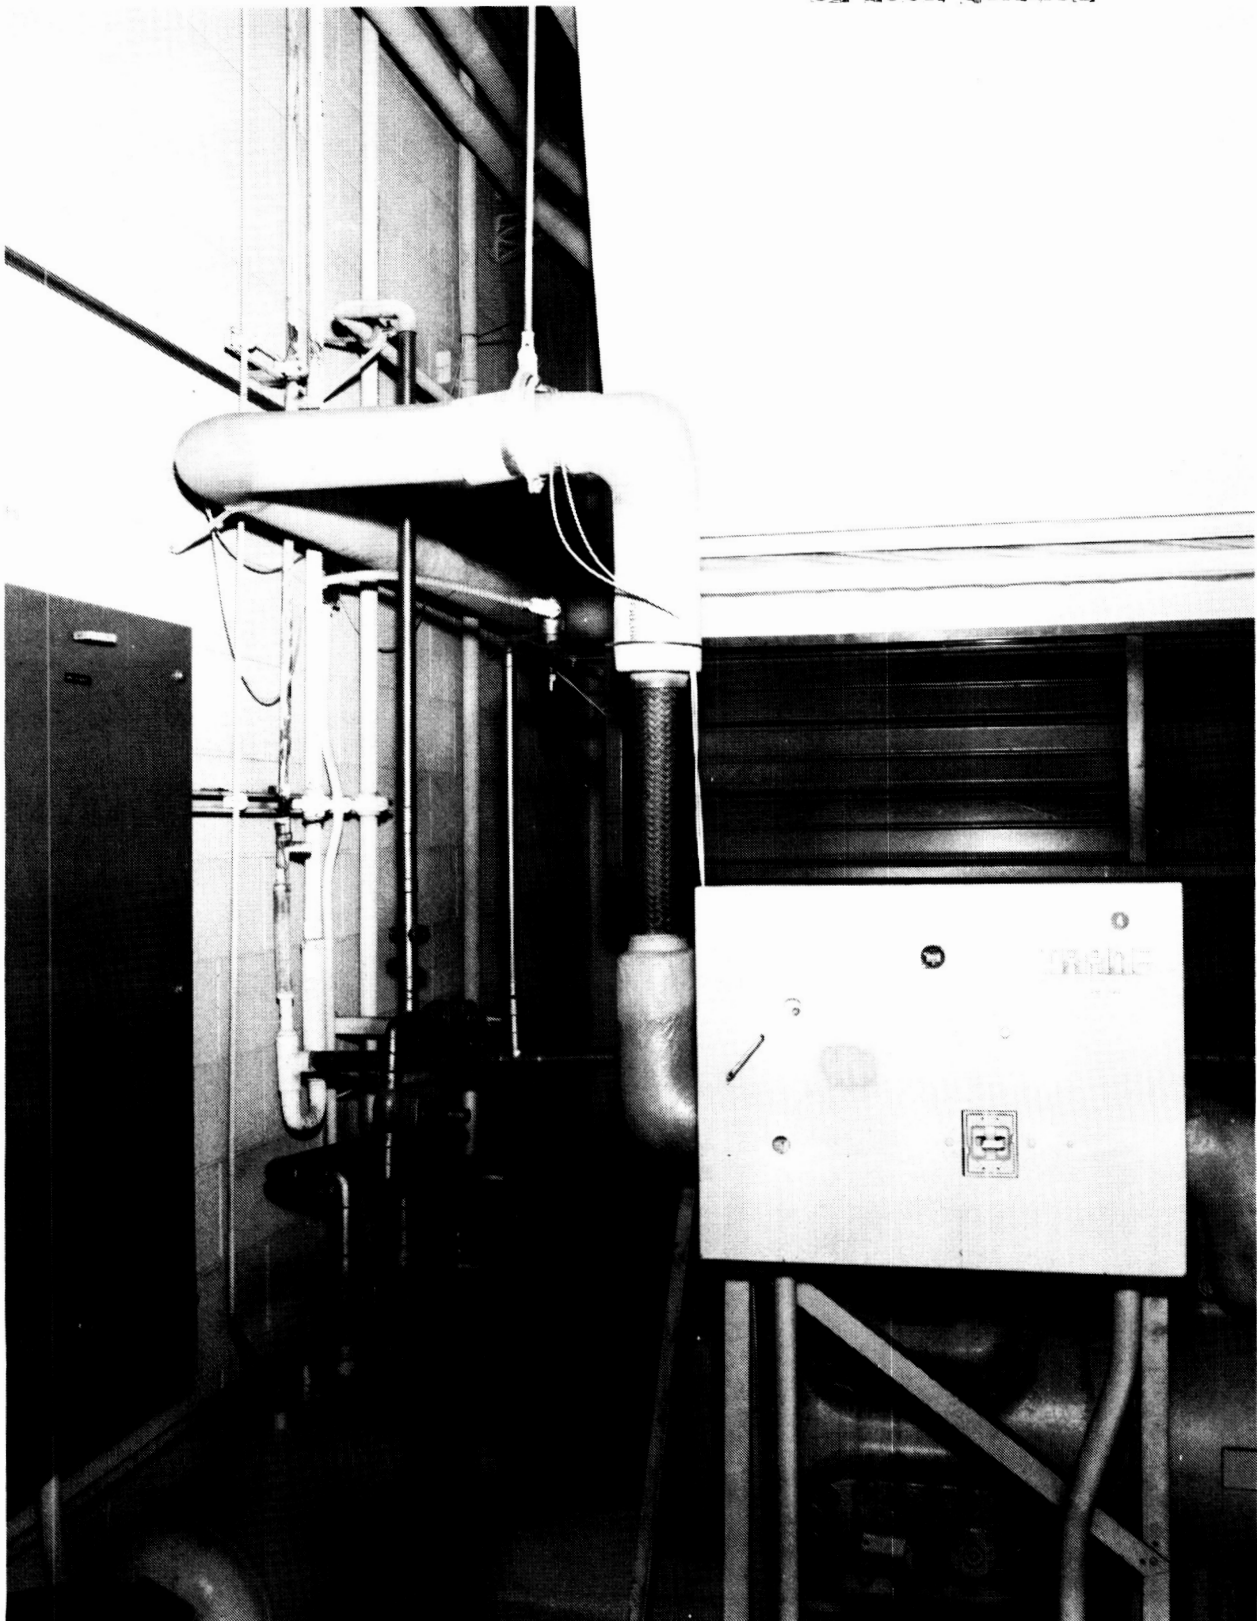
Figure 49. Venus Site: Building G-51, Mechanical Equipment Room 106,  
Asbestos-Containing Pipe Lagging.

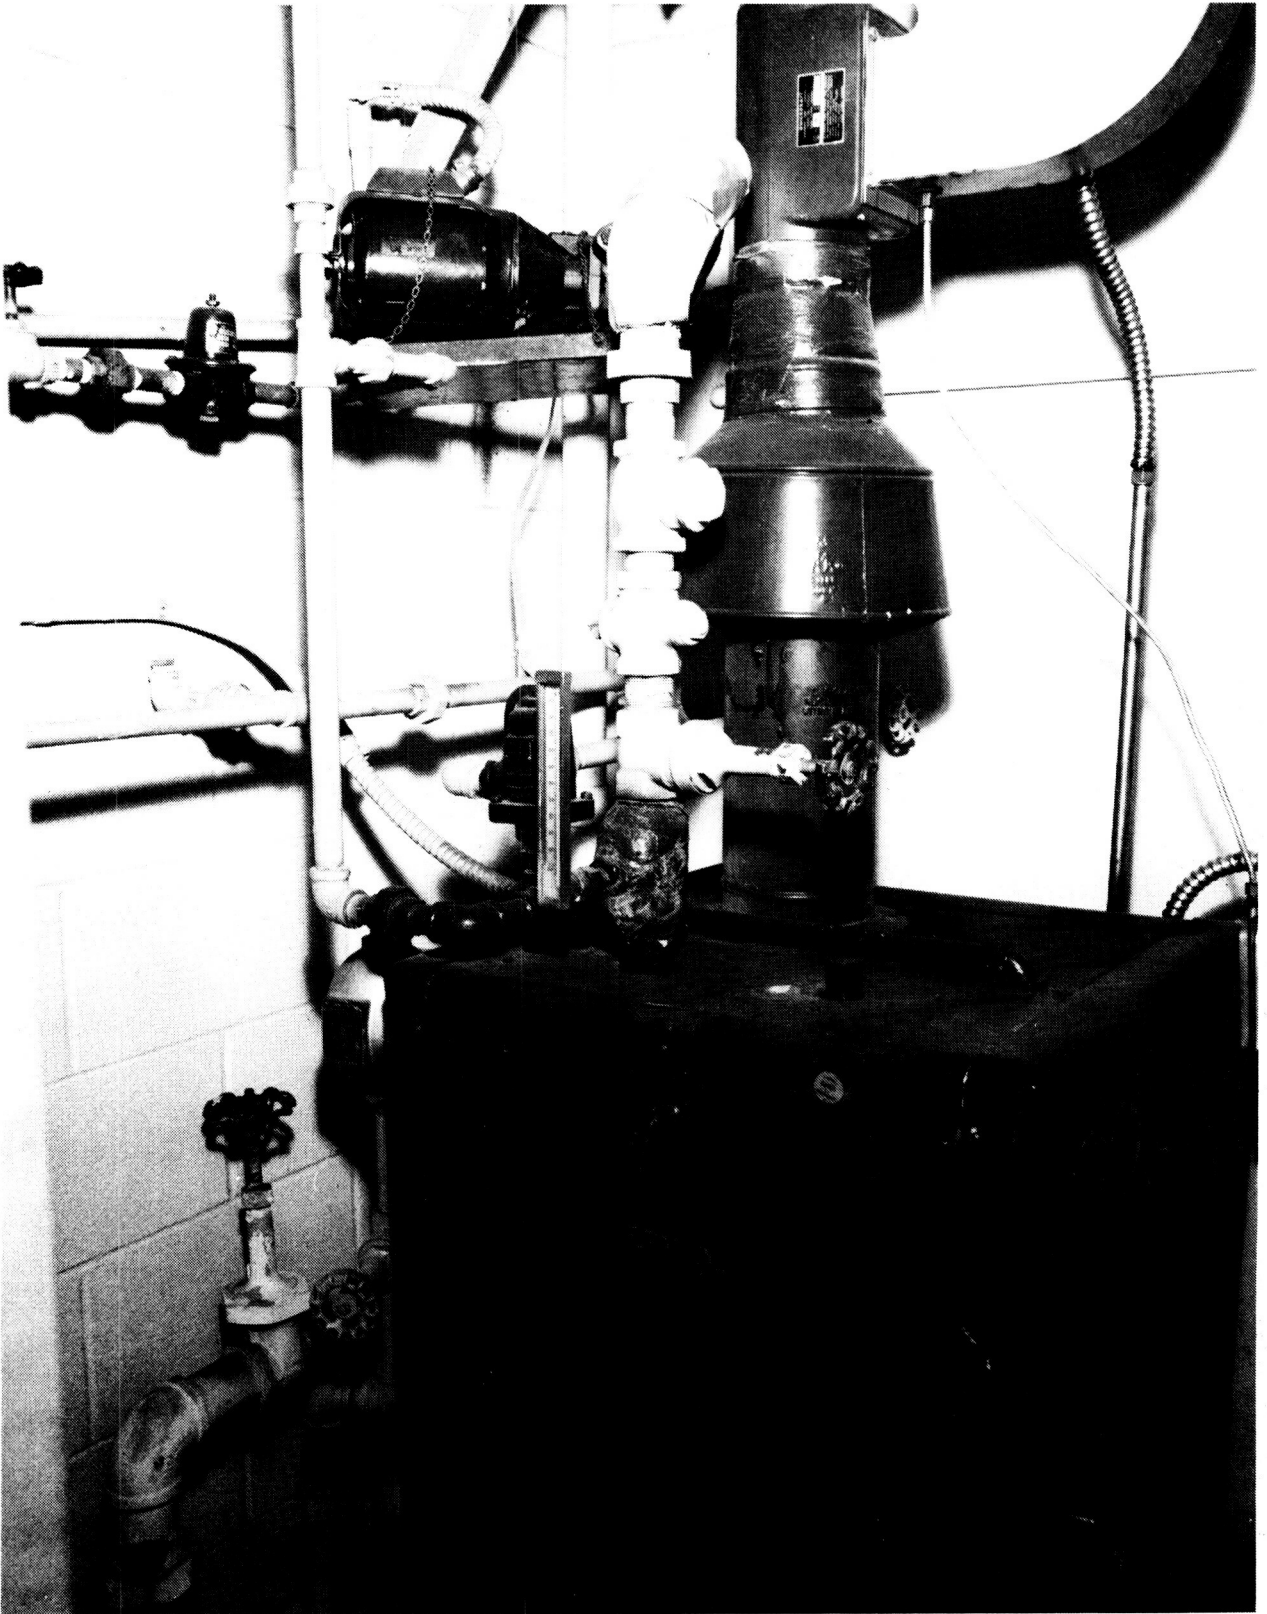
Figure 50. Venus Site: Building G-51, Boiler Room 107, Asbestos-Containing Pipe Lagging.

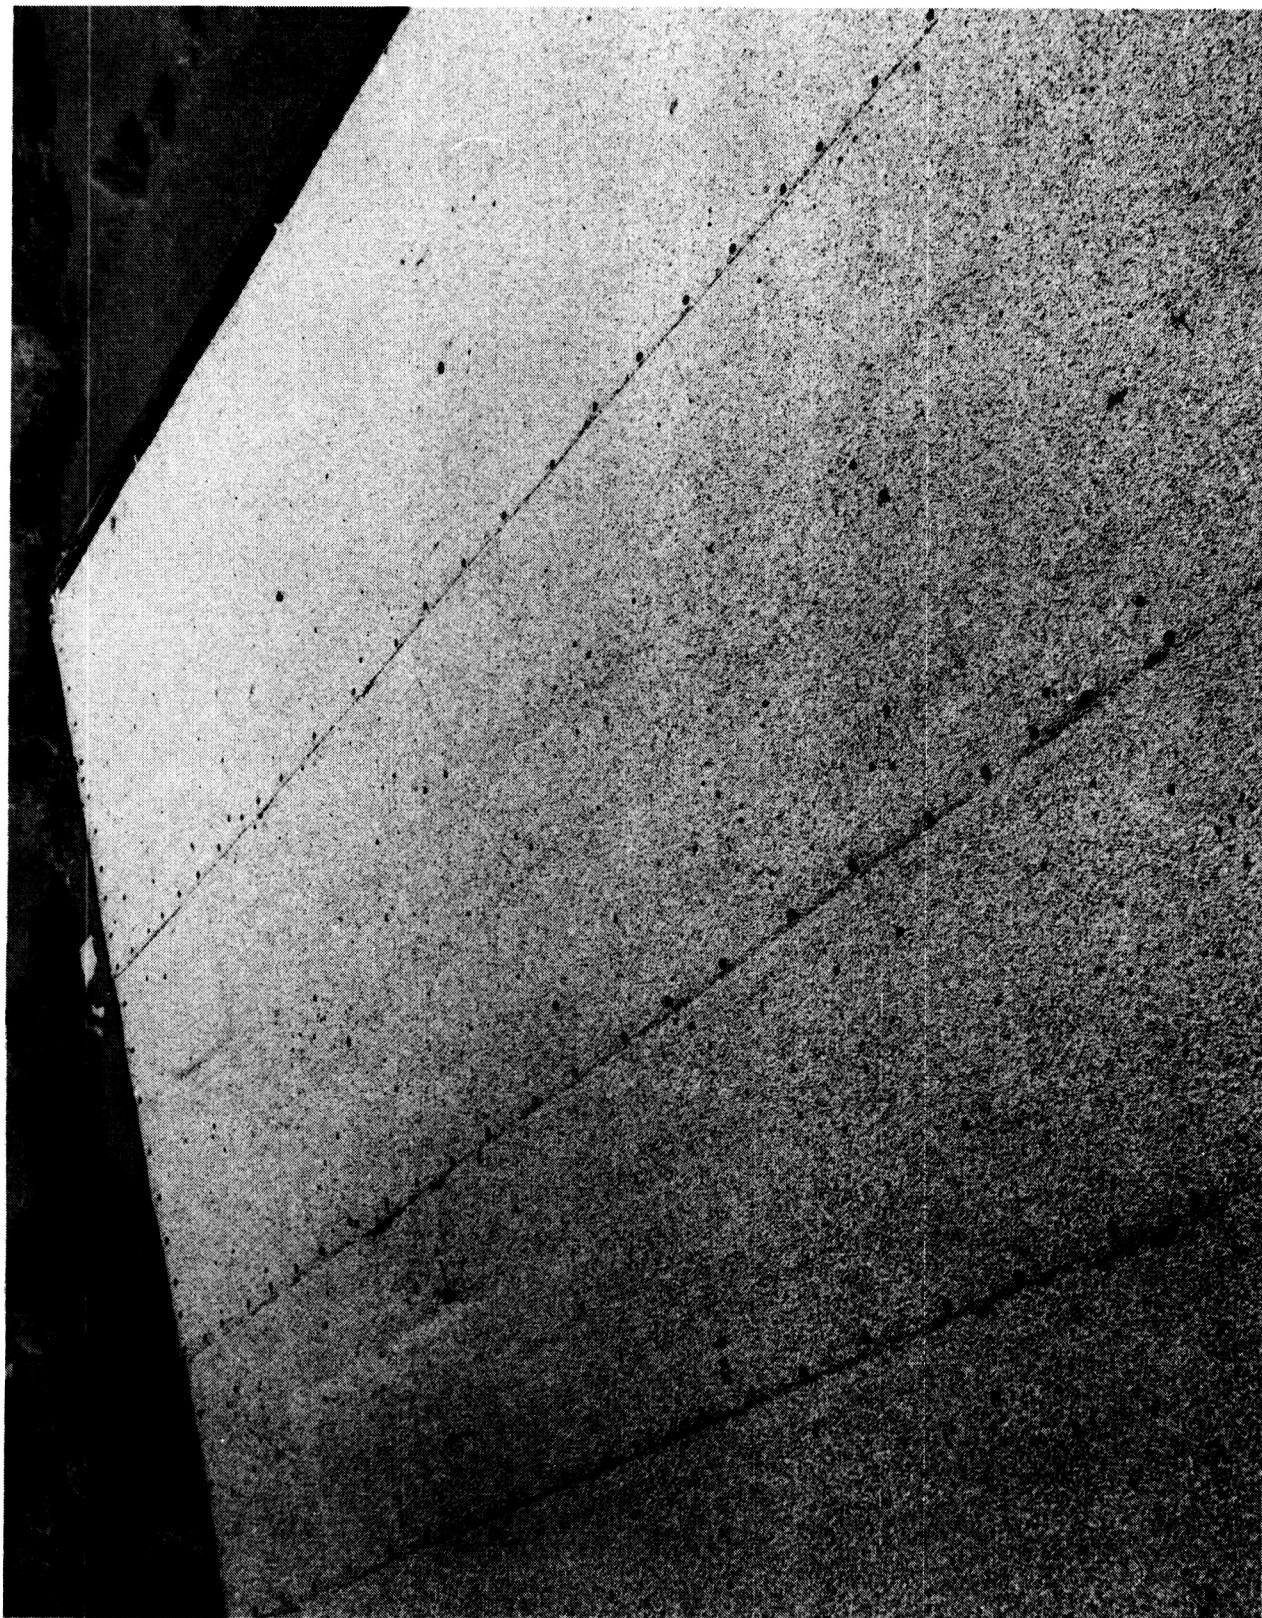
Figure 57. Goldstone Dry Lake Airport: Building G-70, Roof, Asbestos-Containing Roofing Material Typical of Asbestos Roofing Construction for Many Roofs at the GDSCC.

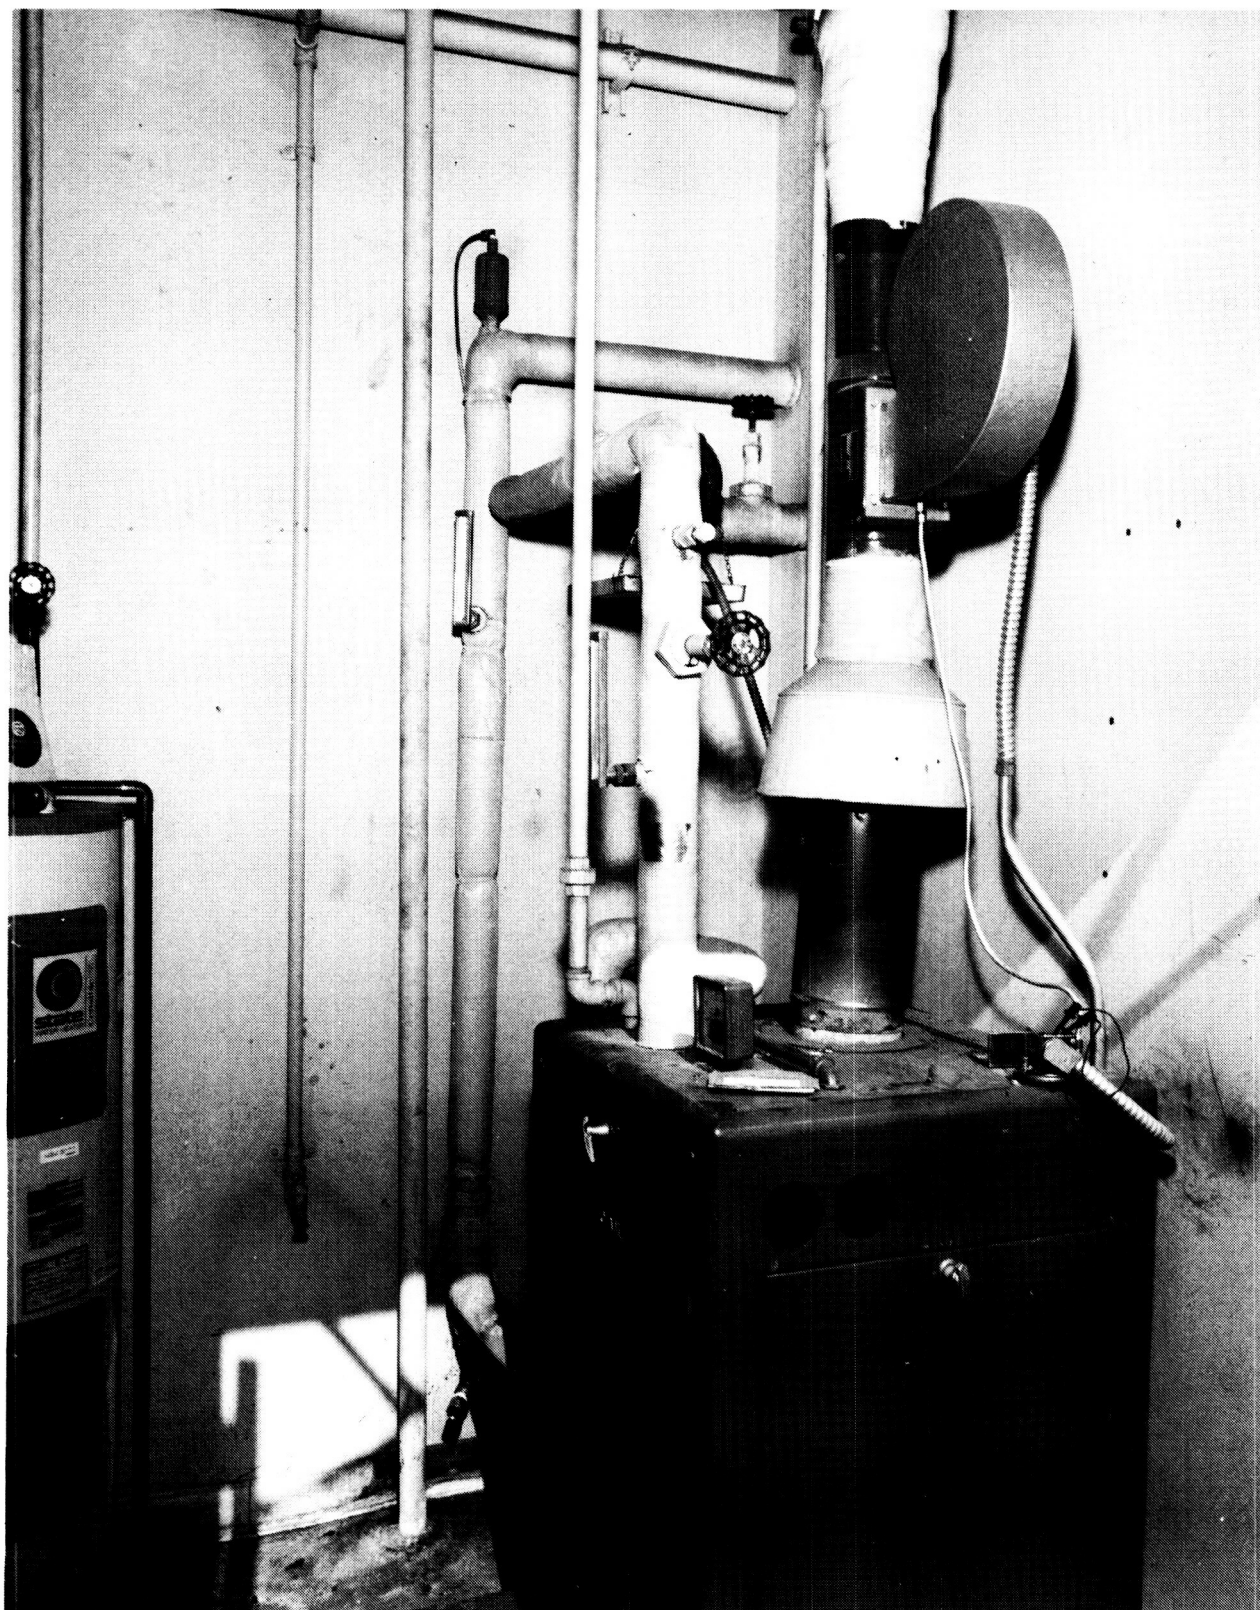
Figure 62. Microwave Test Facility: Building G-72, Boiler Room 110, Asbestos-Containing Pipe Lagging and Boiler Insulation.

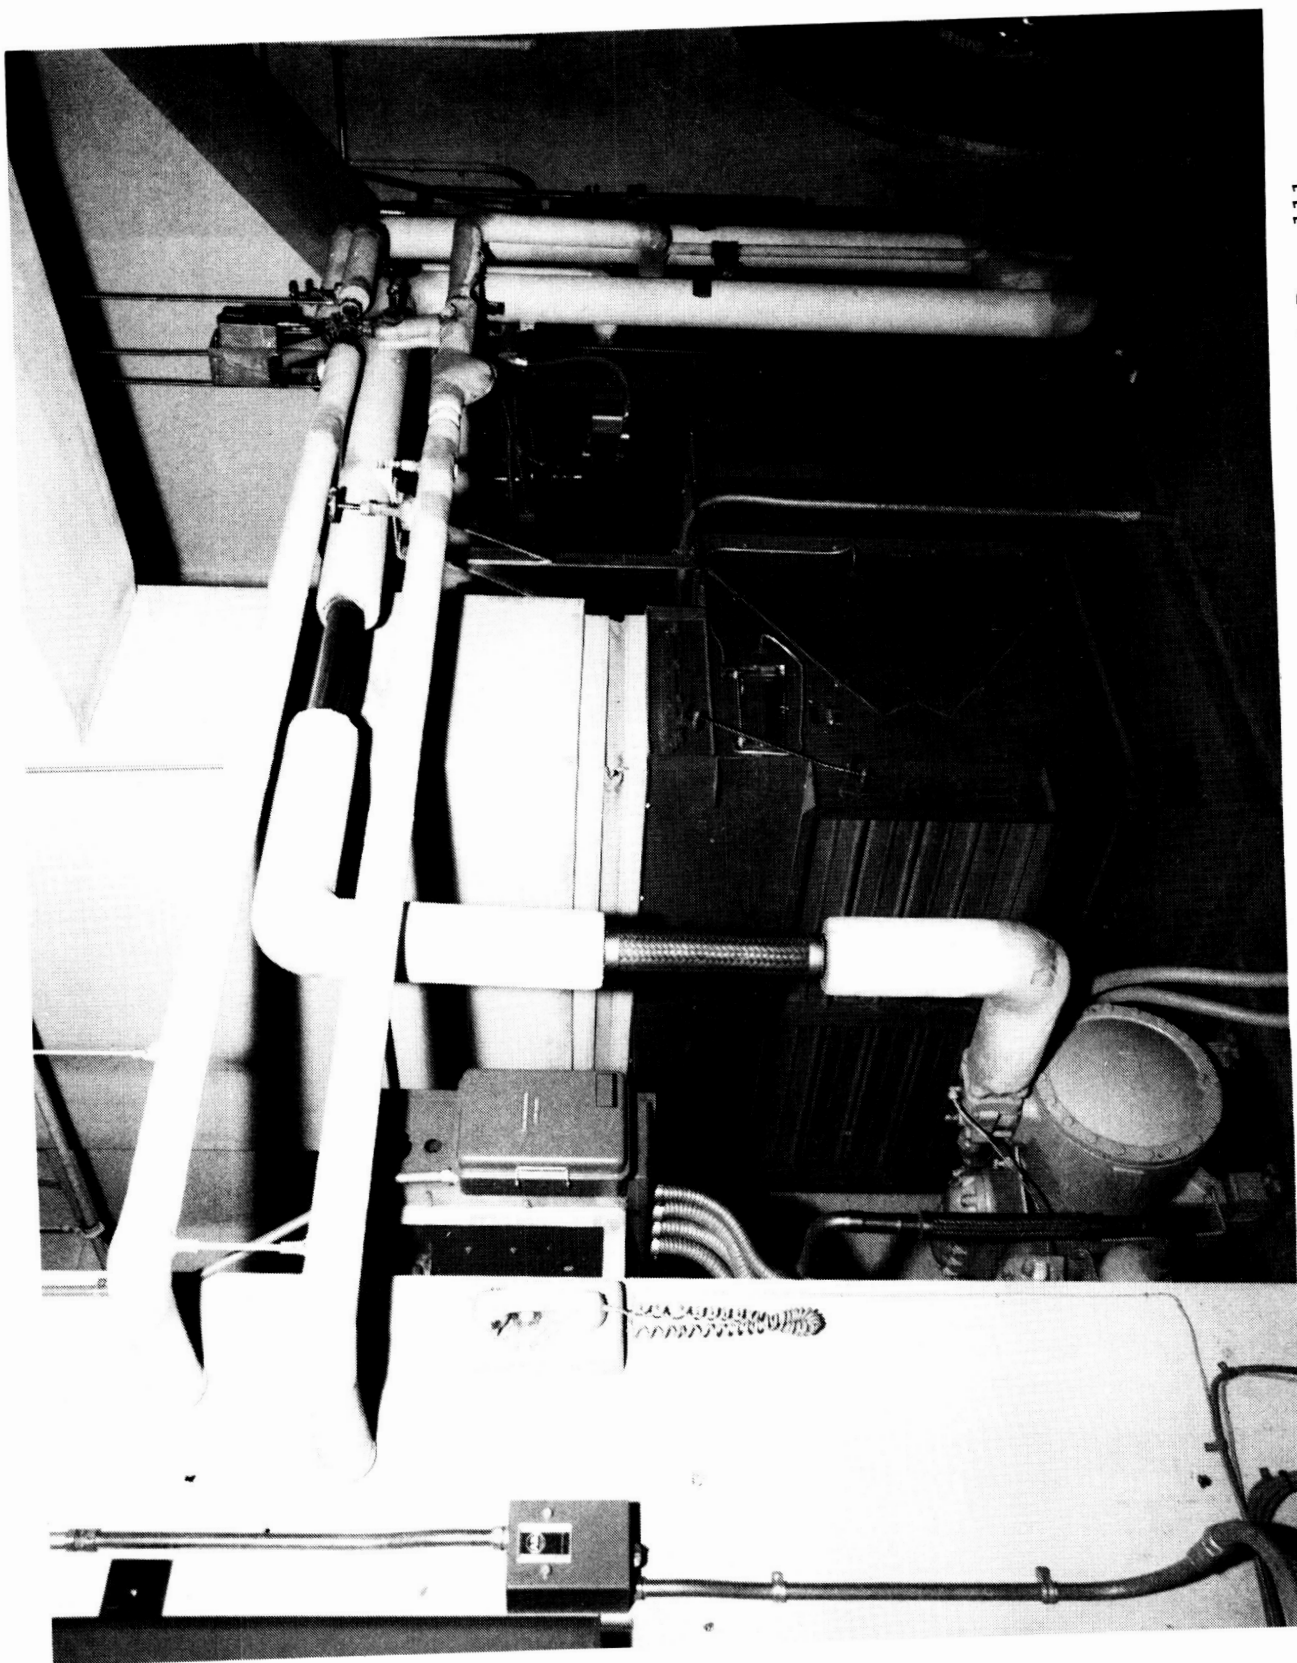
Figure 63. Microwave Test Facility: Building G-72, Mechanical Equipment Room 111, Asbestos-Containing Pipe Lagging.

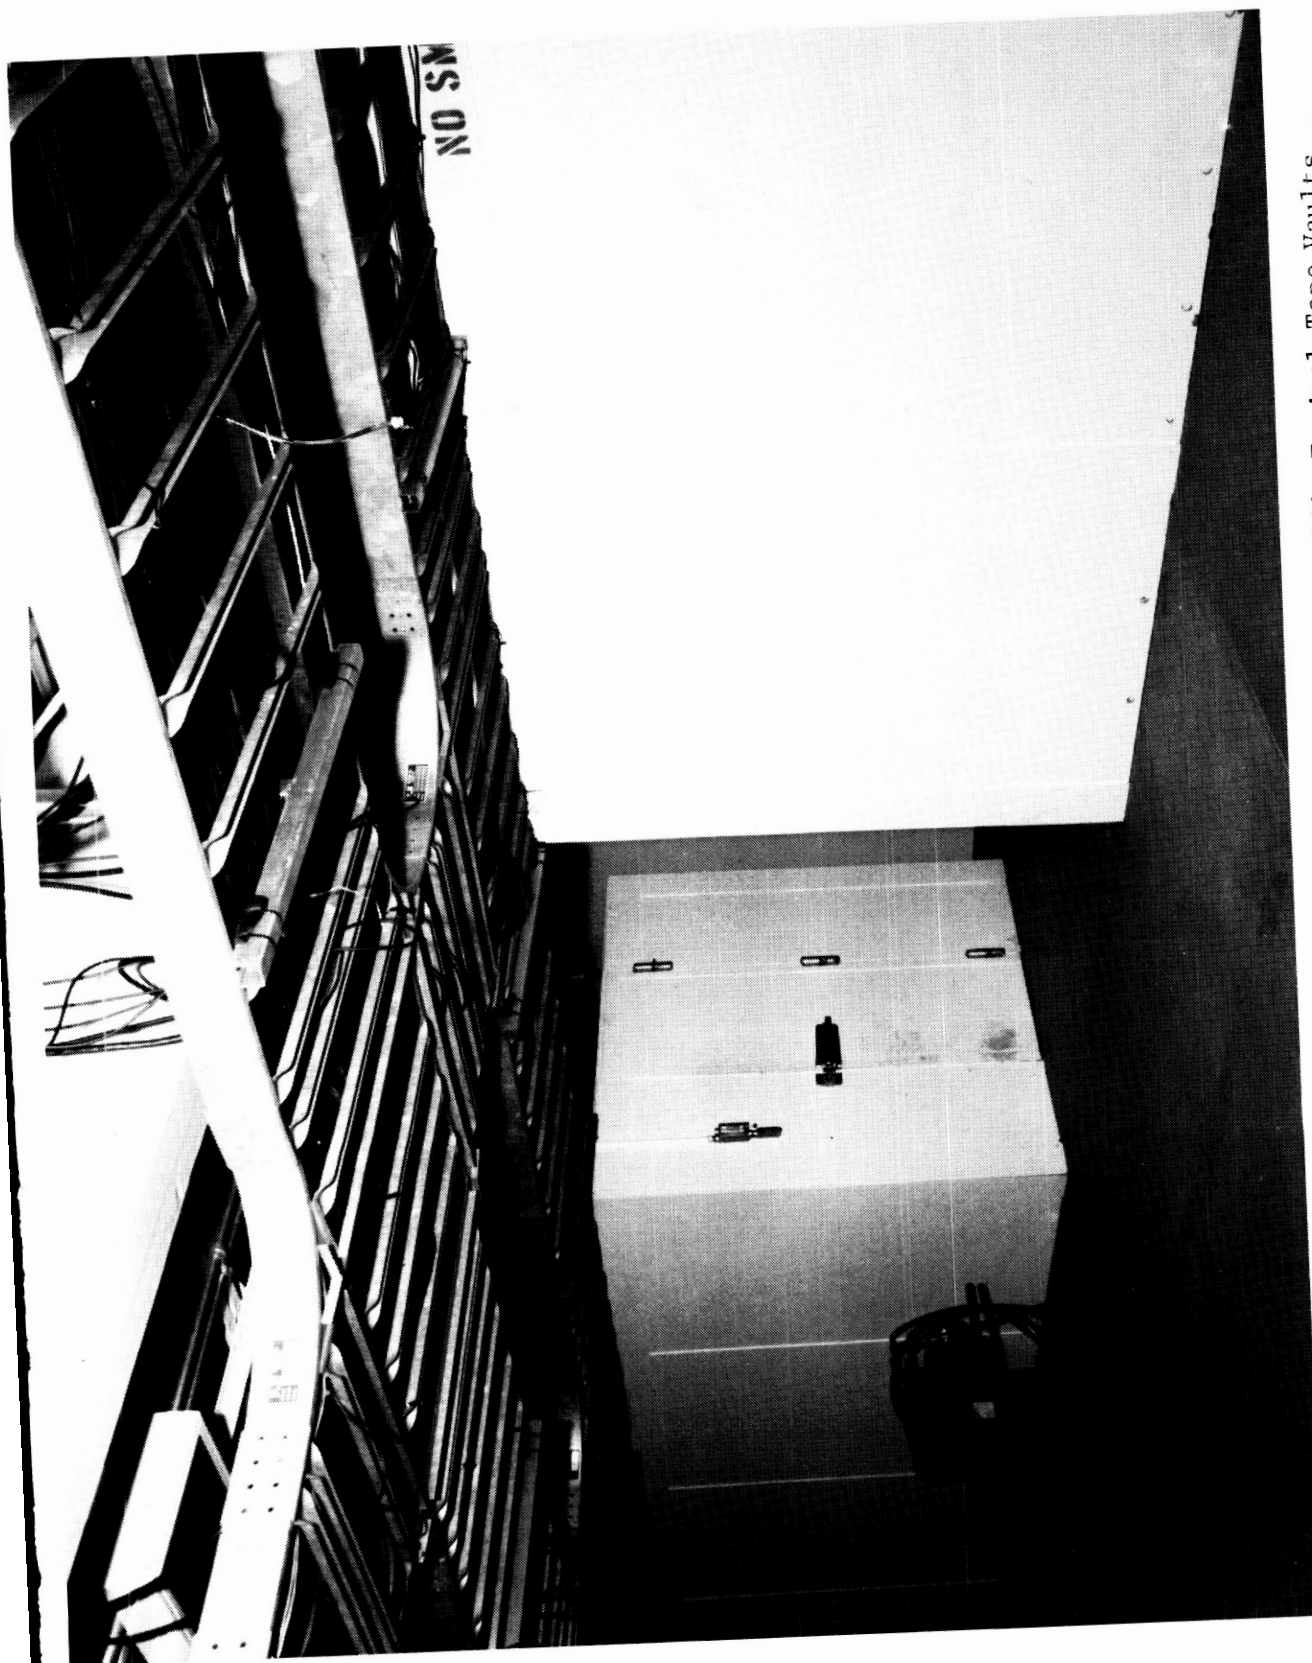
Figure 72. Mars Site: Building G-86, Tape Vault Plenum Room 101, Typical Tape Vaults  
Constructed of Asbestos-Containing Transite Board.

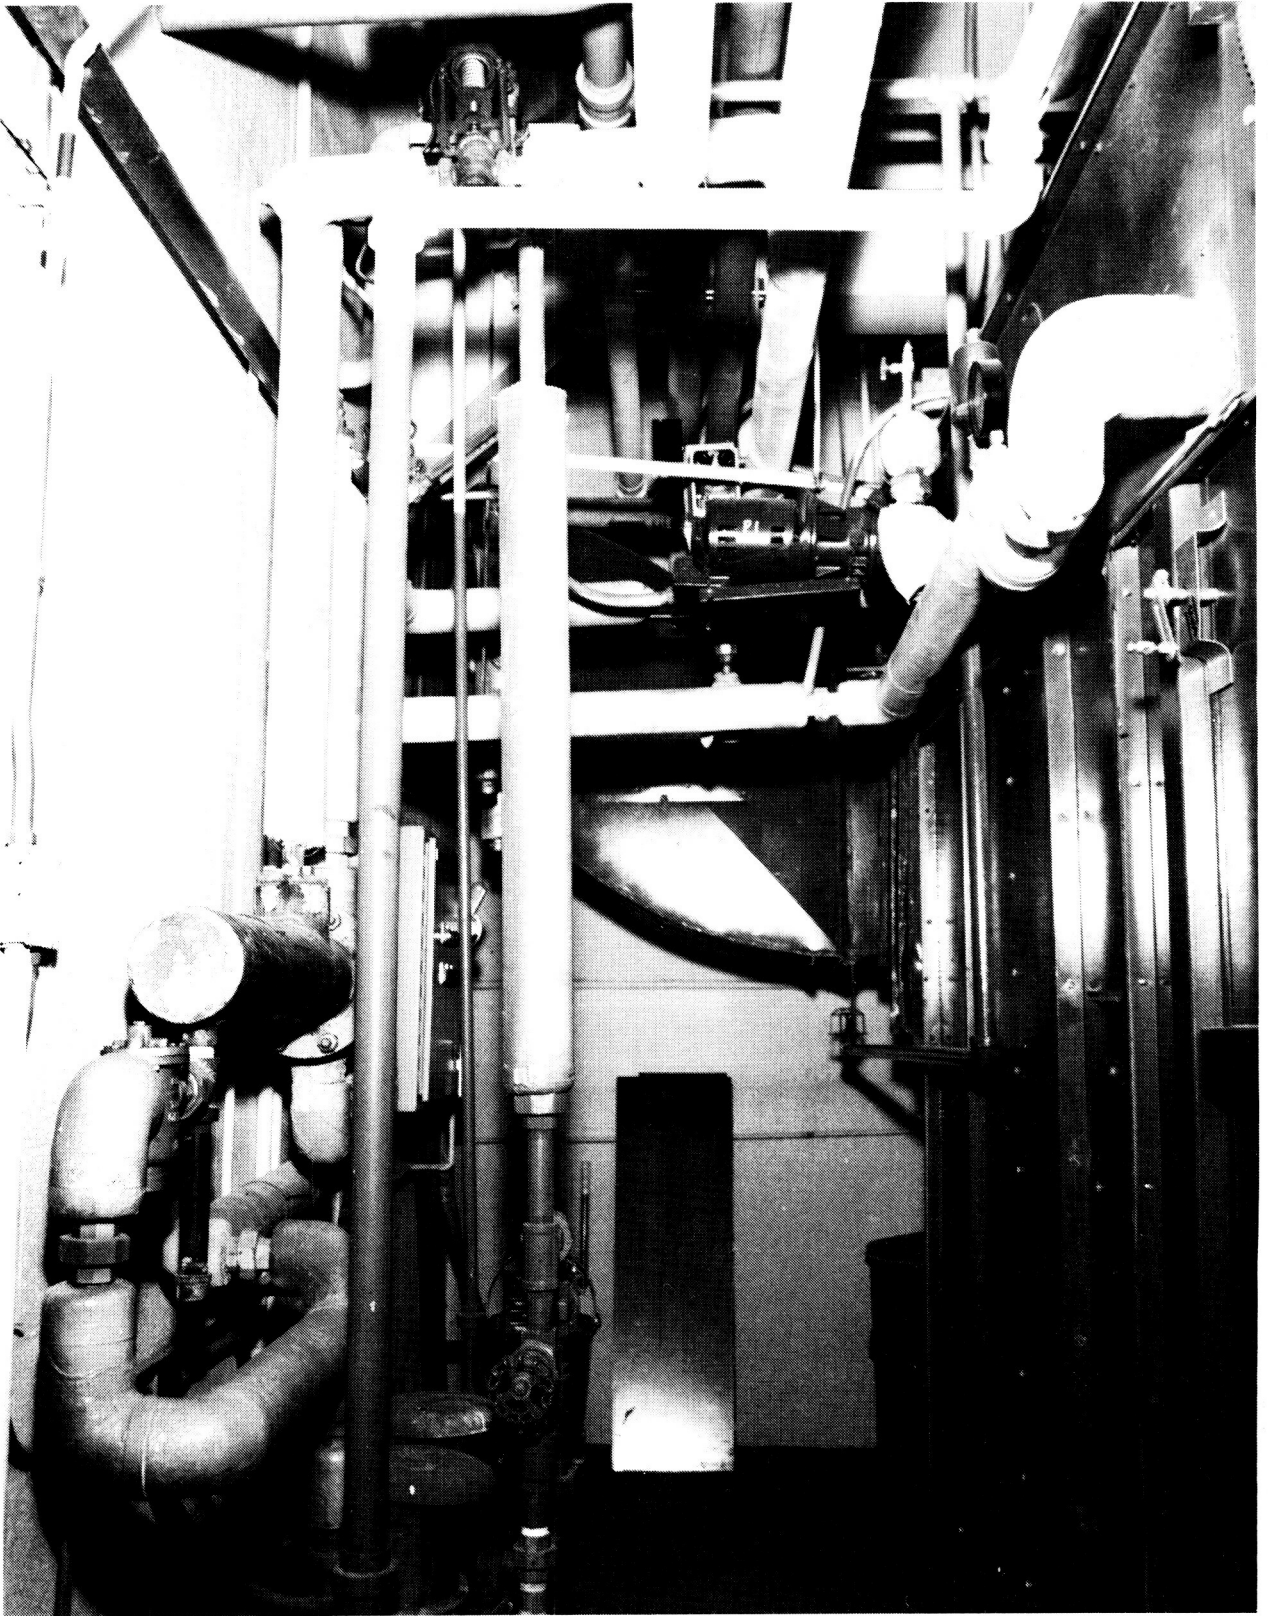
Figure 73. Mars Site: Building G-86, Mechanical Equipment Room 104,  
Asbestos-Containing Pipe Lagging.

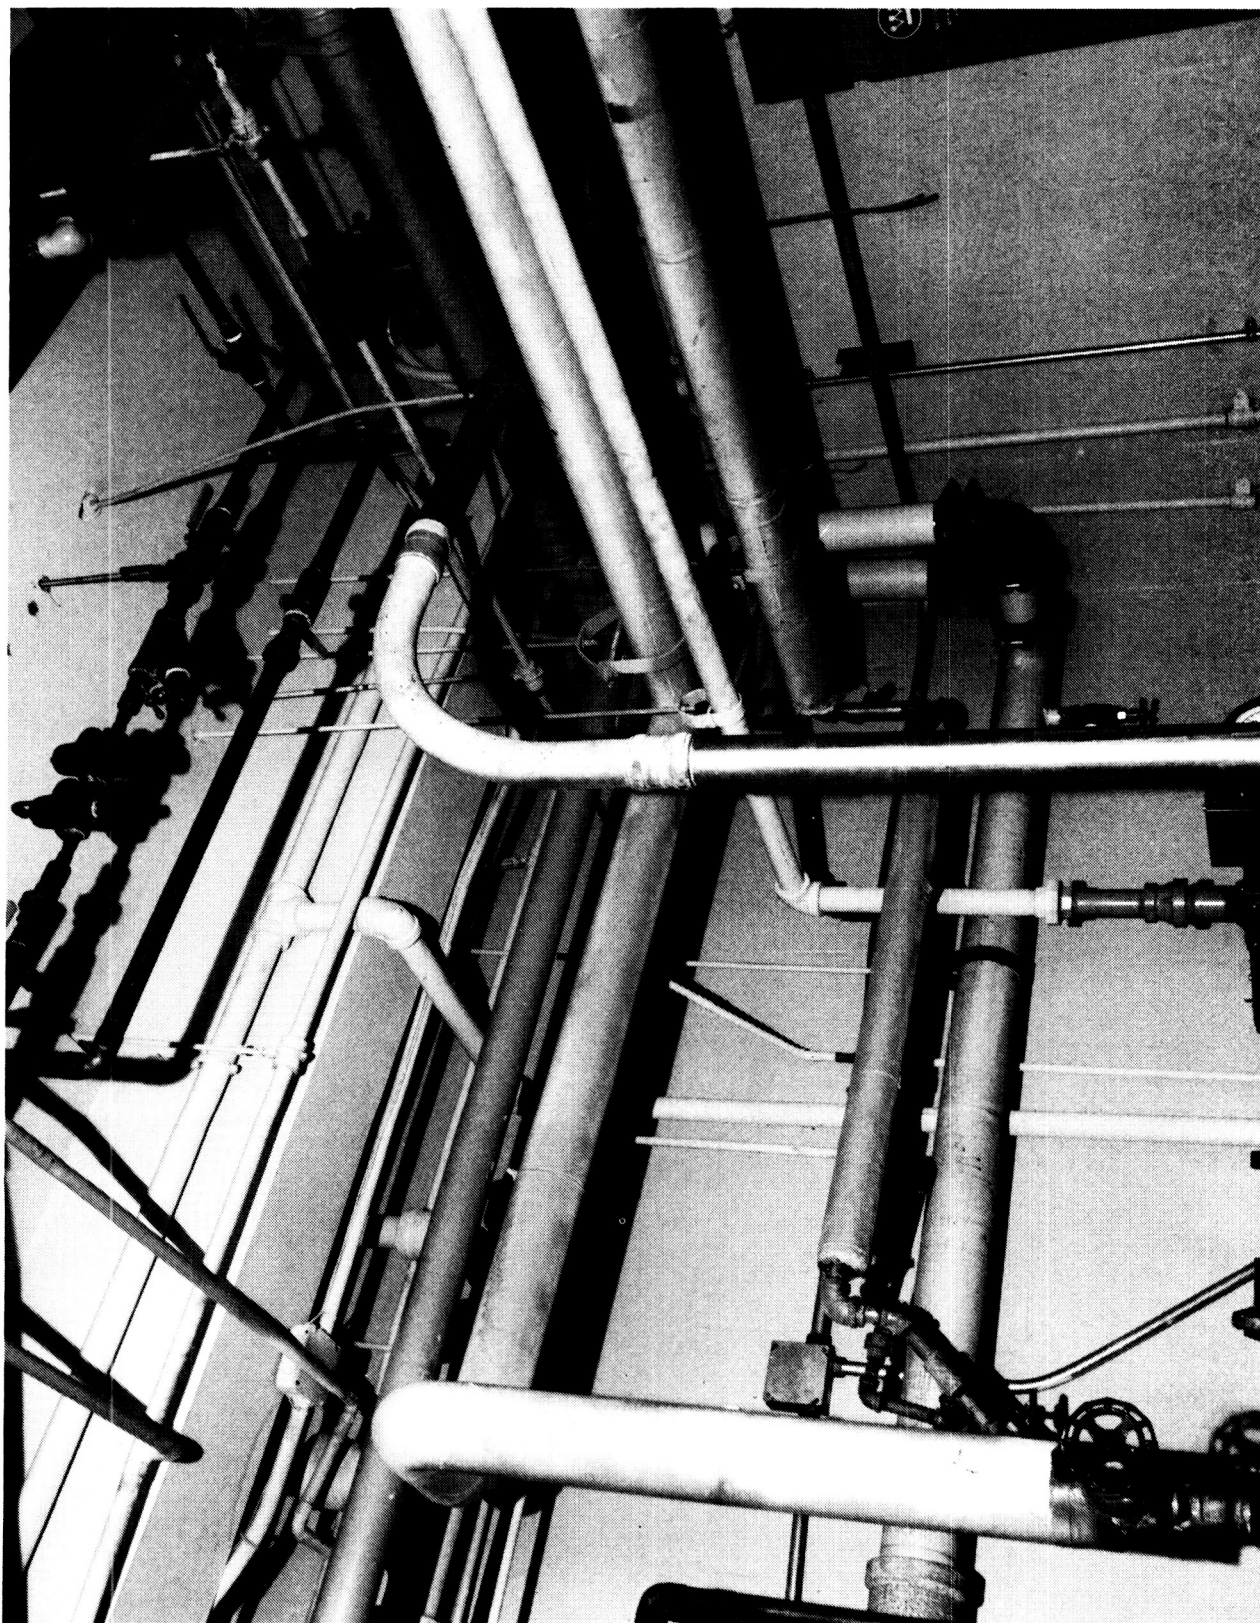
Figure 74. Mars Site: Building G-86, Mechanical Equipment Room 104,  
Asbestos-Containing Pipe Lagging.

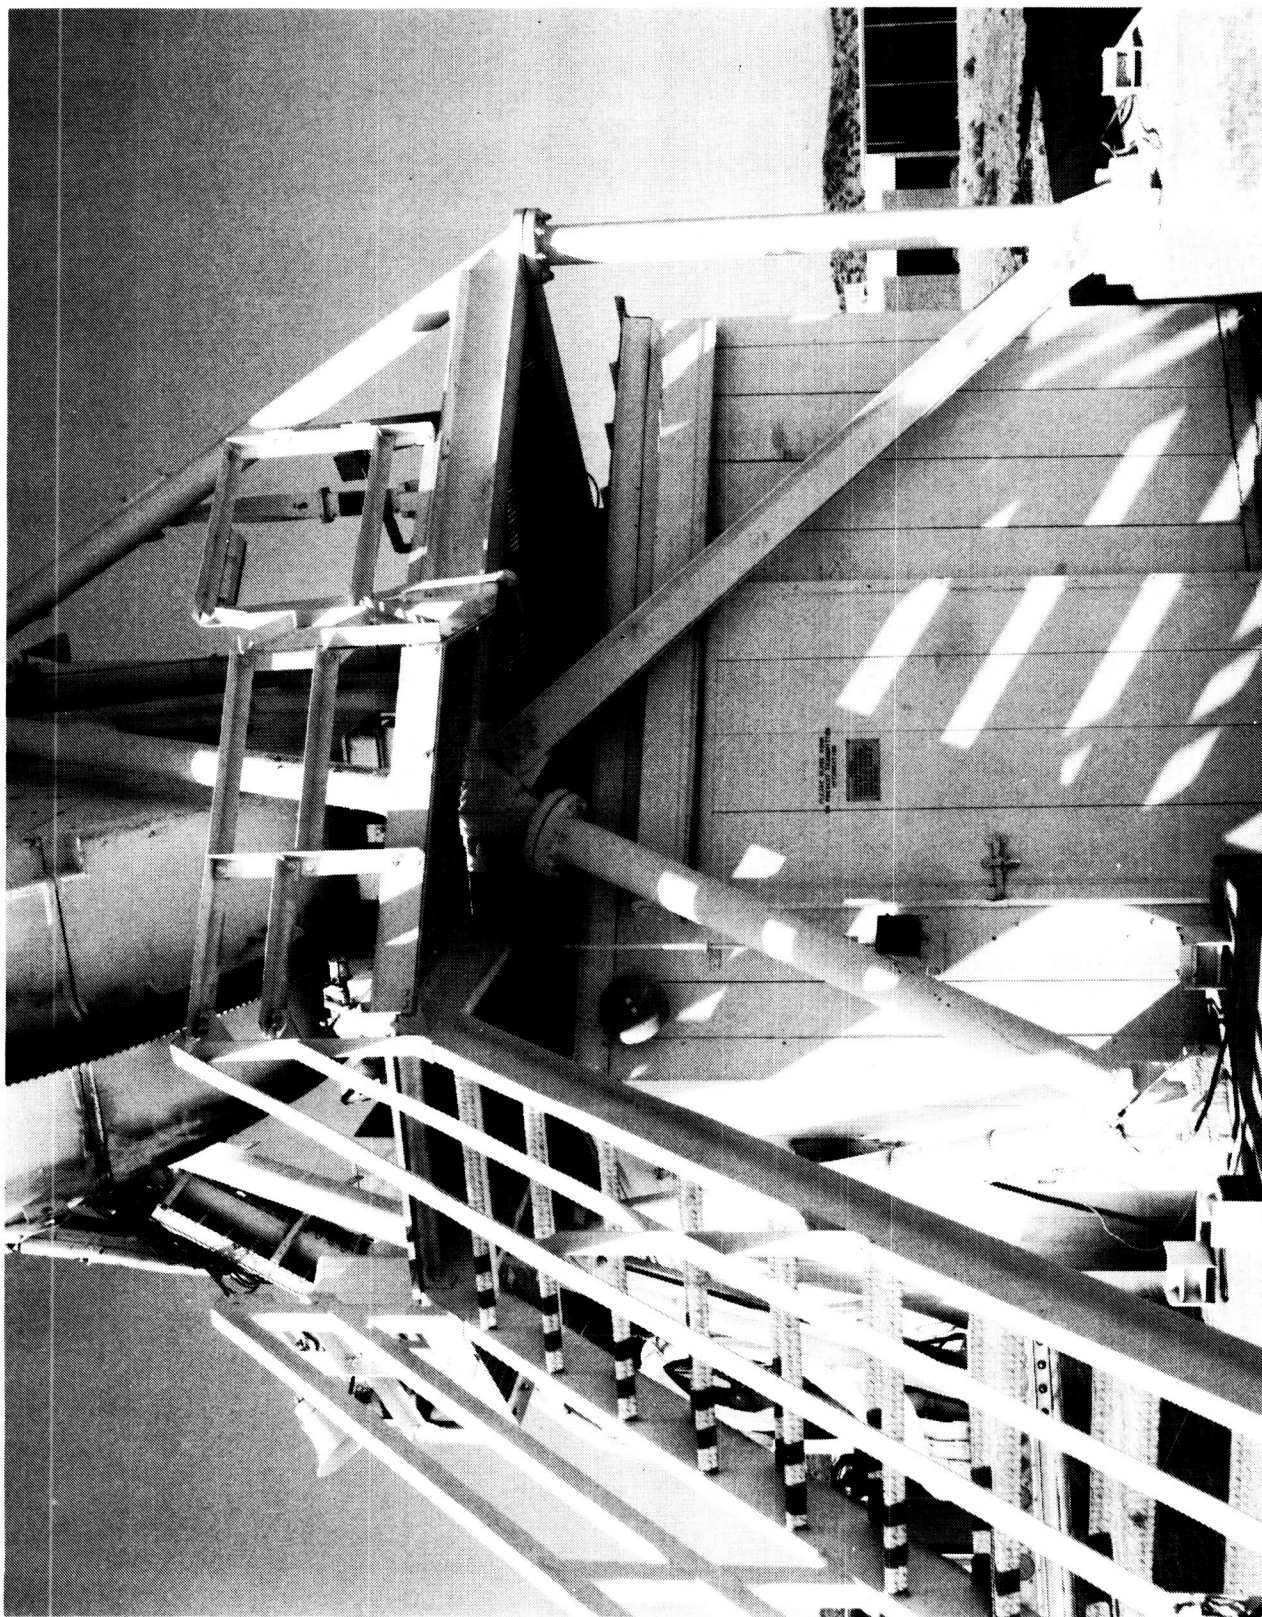
Figure 81. Apollo Site: Building A-7, Asbestos-Containing Insulation in Wall Structure.

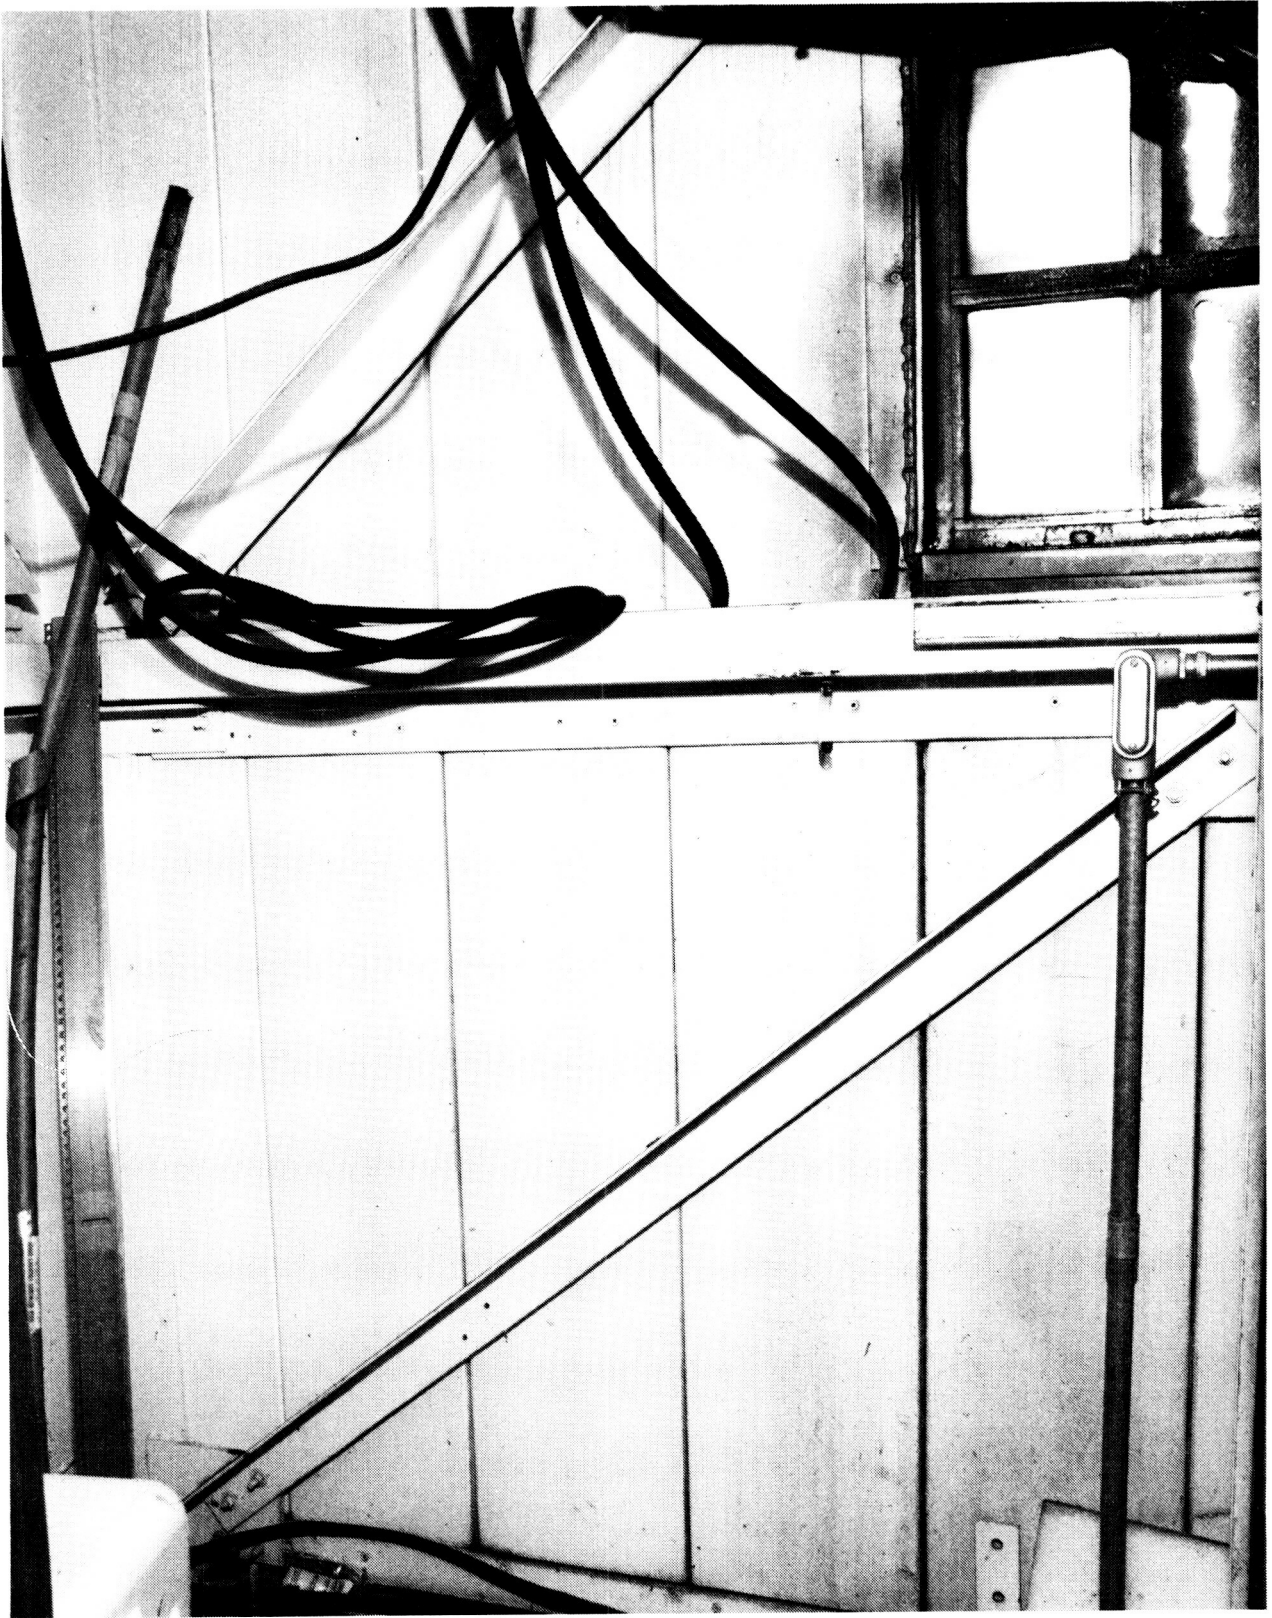
Figure 82. Apollo Site: Building A-7, Asbestos-Containing Insulation in Wall Structure.

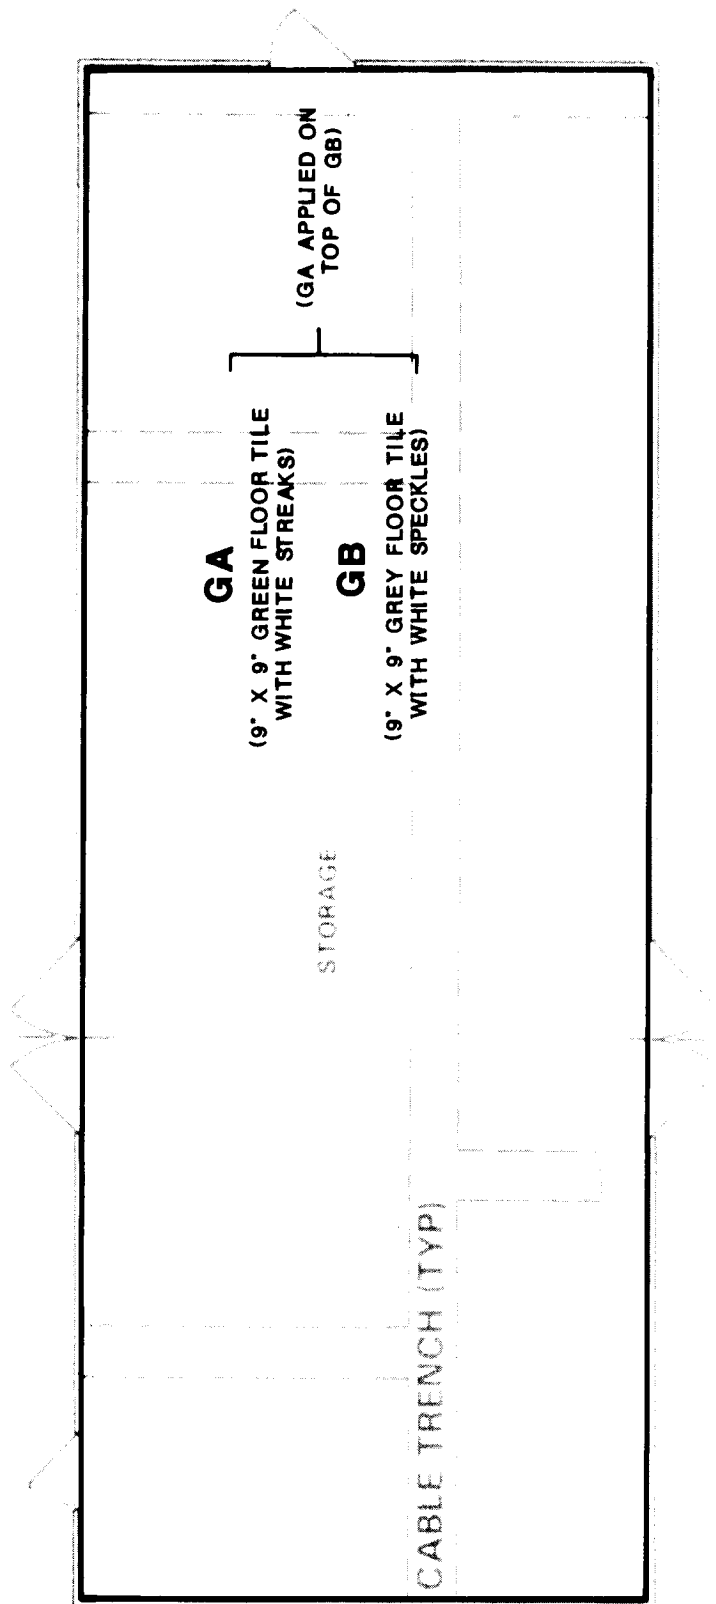
Figure 86. Mojave Base Site: Logistics Building M-2

Comments: 9 X 9 in. GRAY TILE WITH WHITE SPECKS. GREEN TILE (REF. GA) APPLIED ON TOP OF THIS MATERIAL. SEE FIGURE 86
